REPORT
ON
THE FLOODS OF THE MOIRA RIVER,
AT
BELLEVILLE, ONT.

APRIL, 1920.

WALTER J. FRANCIS & COMPANY
CONSULTING ENGINEERS
MONTREAL.

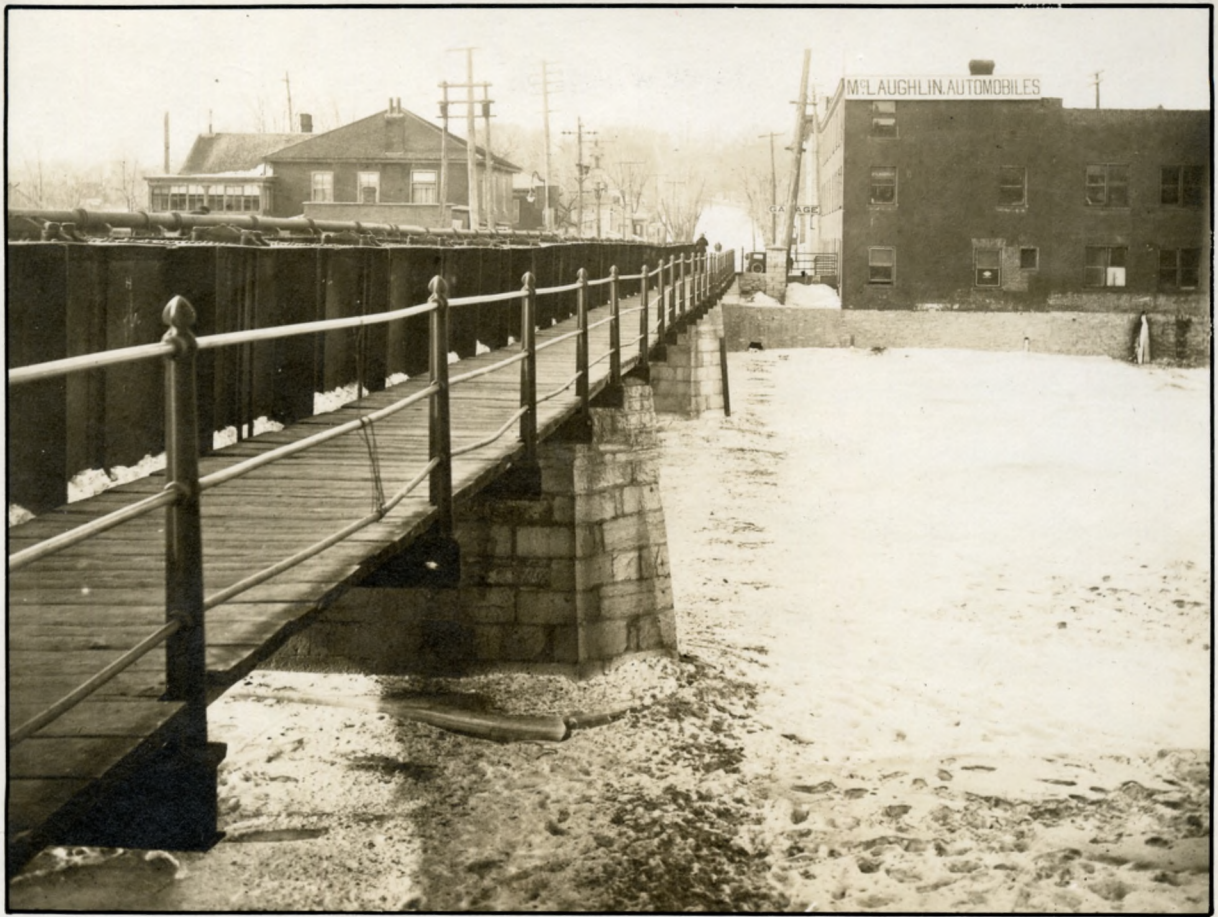
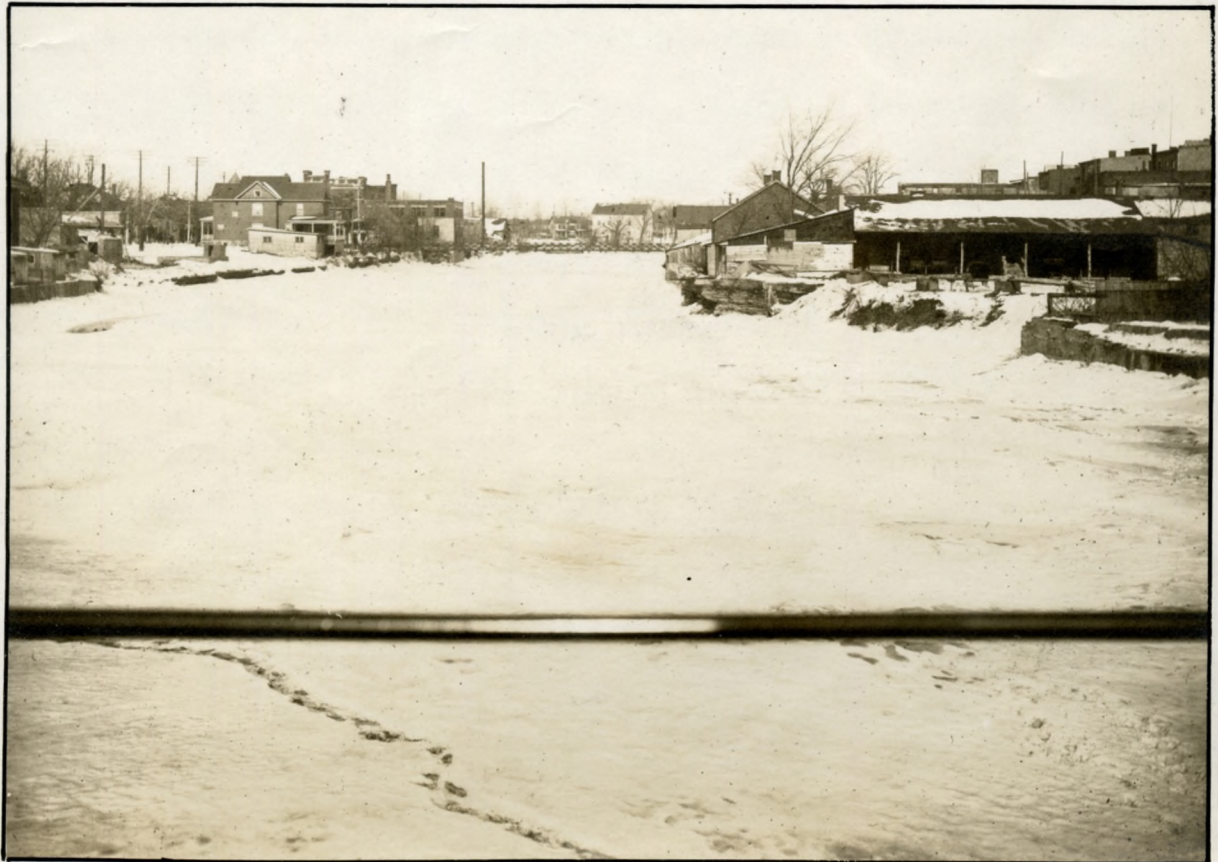
Photograph No. 1.

from the Center of the Lower Bridge.

Taken February 3, 1920.

The Lower Bridge has three spans, 59 feet, 64 feet and 62 feet in the clear, with two masonry piers 6 feet wide. The clear waterway below the underside of the girders is 3,898 square feet. The upstream side is shown in photograph No. 1, while a view looking upstream from this bridge, with the Foot Bridge in the background, is shown in photograph No. 2, both on page 8.

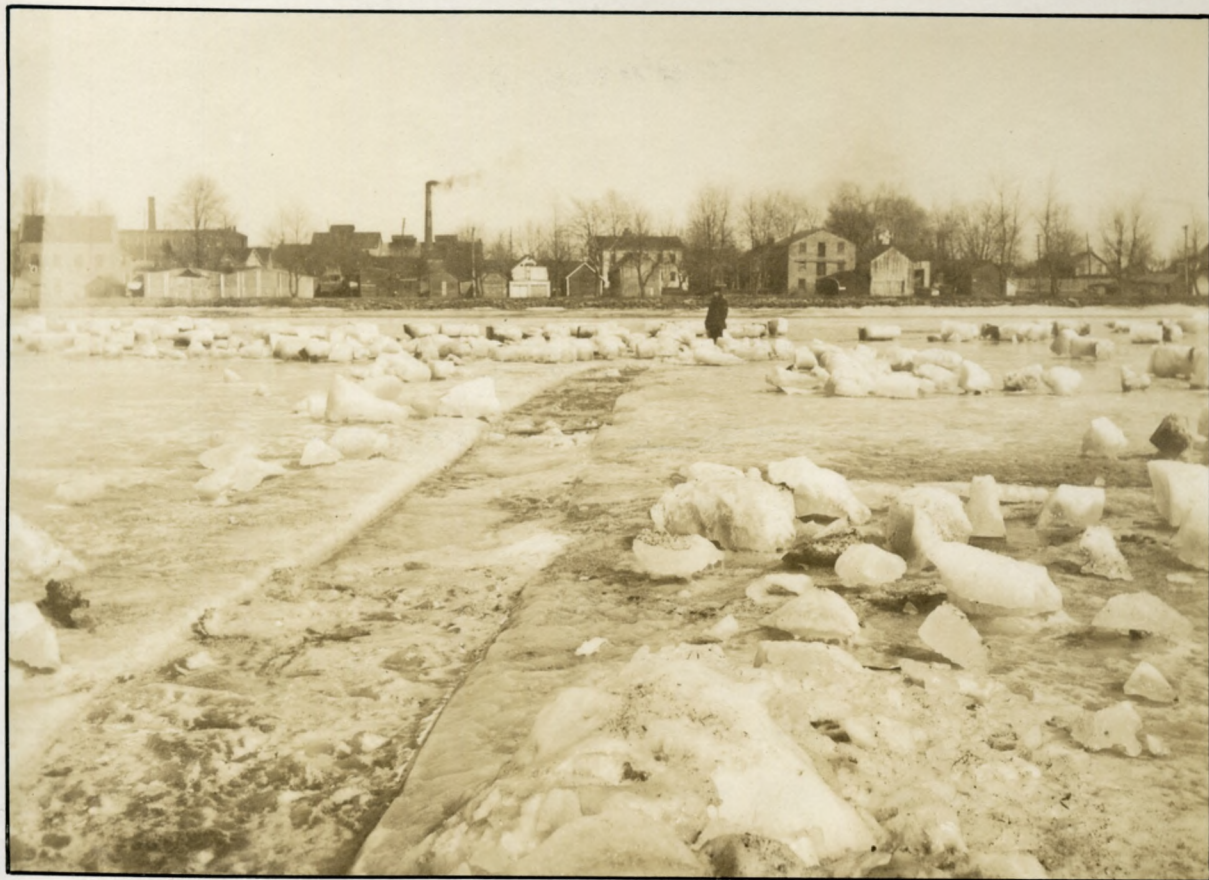
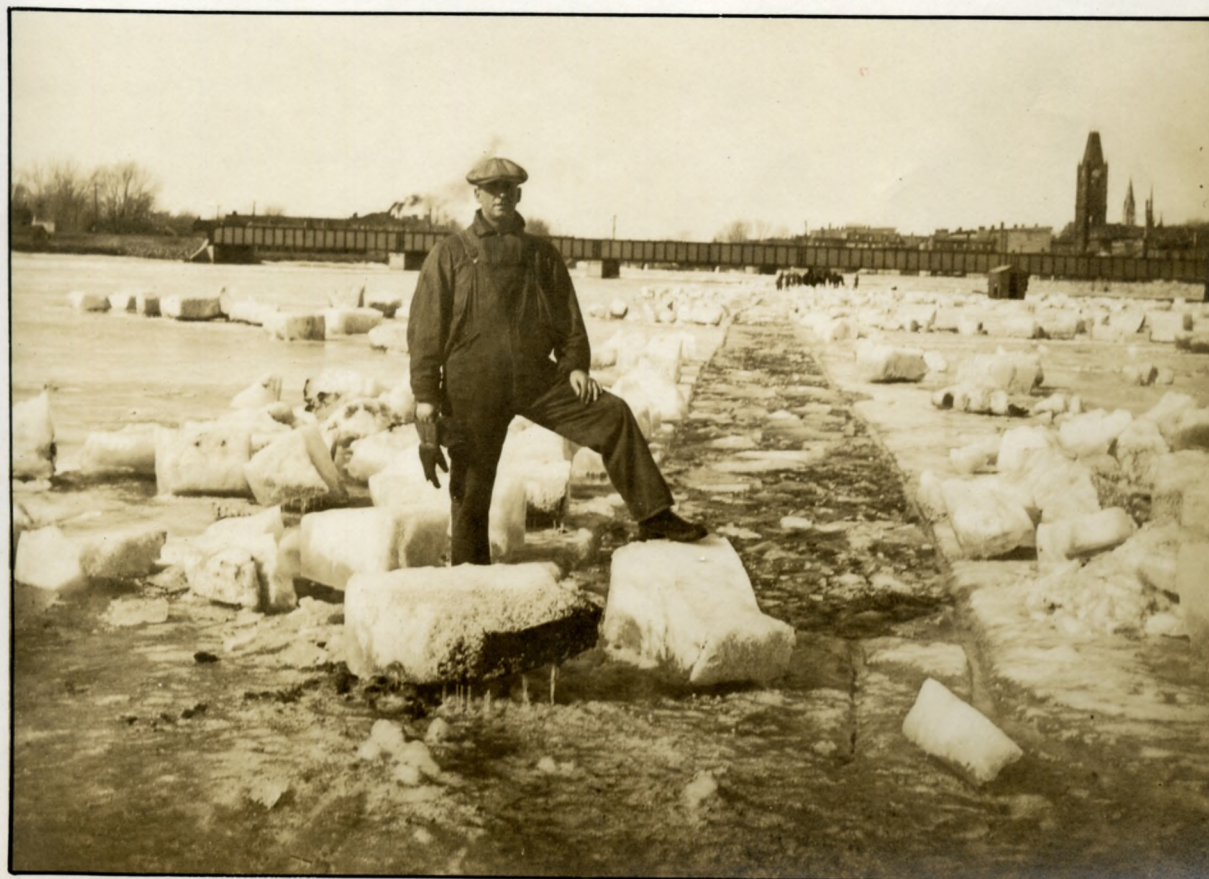
Looking North.

Taken March 18, 1920

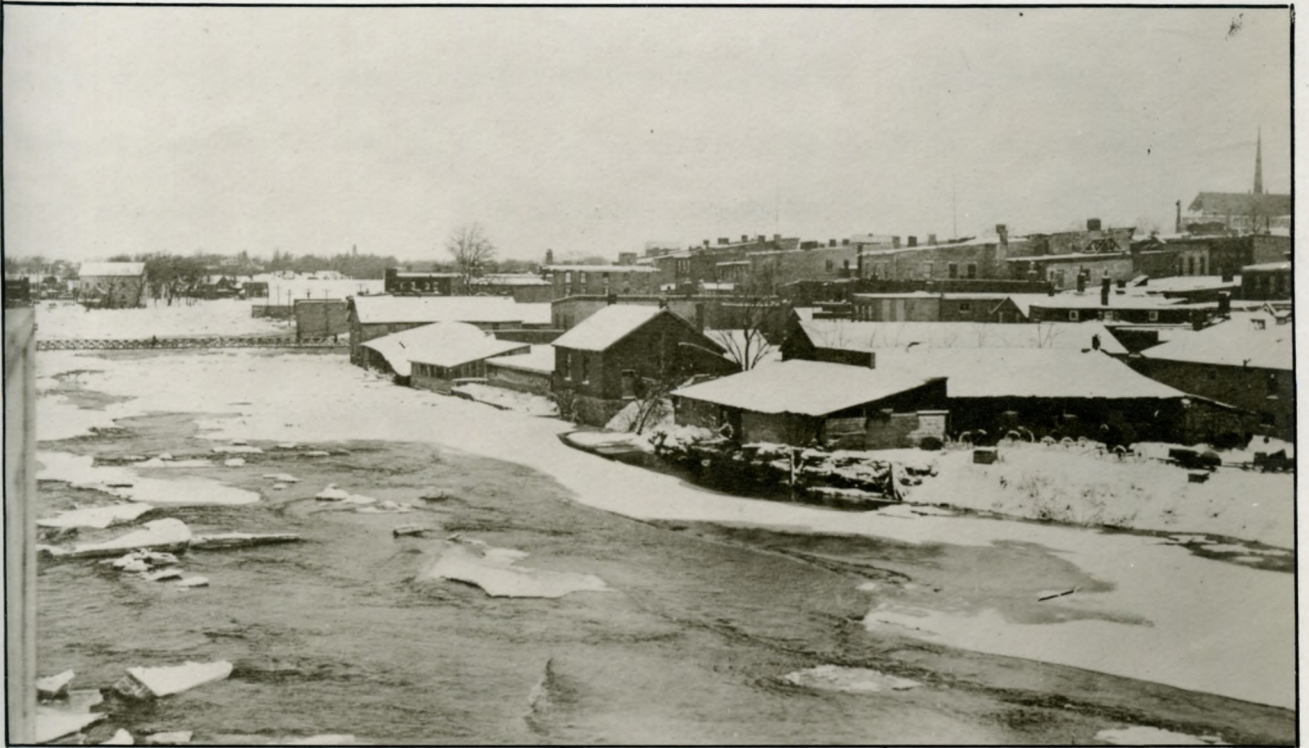
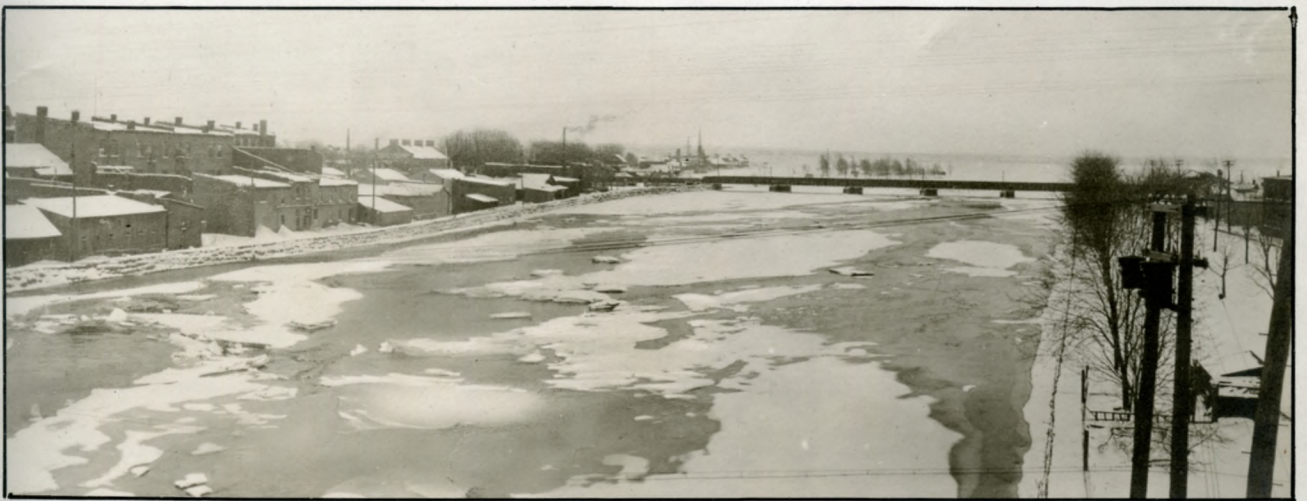
Photograph No. 8.

View of River, South of the Lower Bridge,
Looking South from McLaughlin Garage.

Taken March 20, 1920

During Thursday, Friday and Saturday, March 18th, 19th and 20th, there were only minor changes in the situation. The river opened up very considerably in the neighbourhood of the Foot Bridge, and the ice between the Lower Bridge and the Railway Bridge broke up in many places, as shown in photographs Nos. 6 and 9 on page 18, permitting a quantity of water to flow over the surface. The flow of the river steadily increased until by Saturday, March 20th, it averaged 2,300 cubic feet per second.

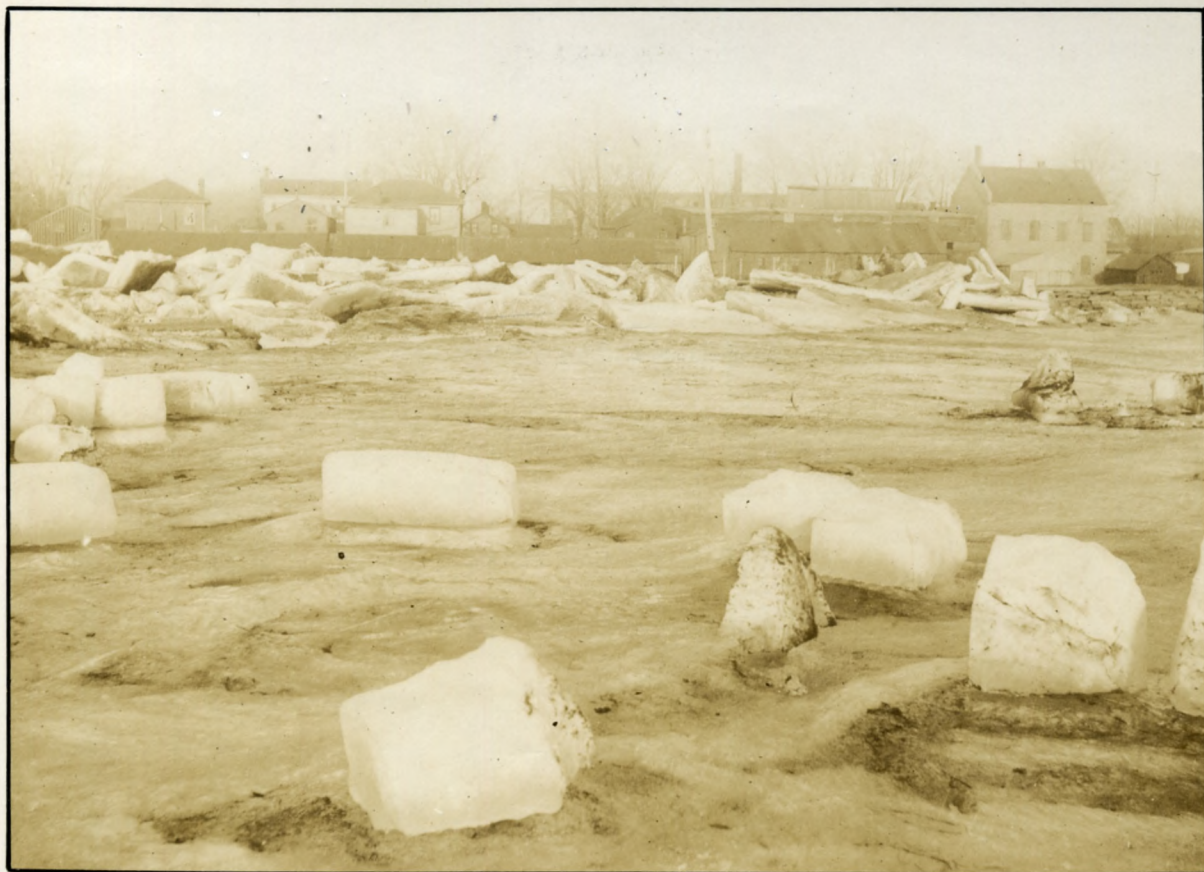
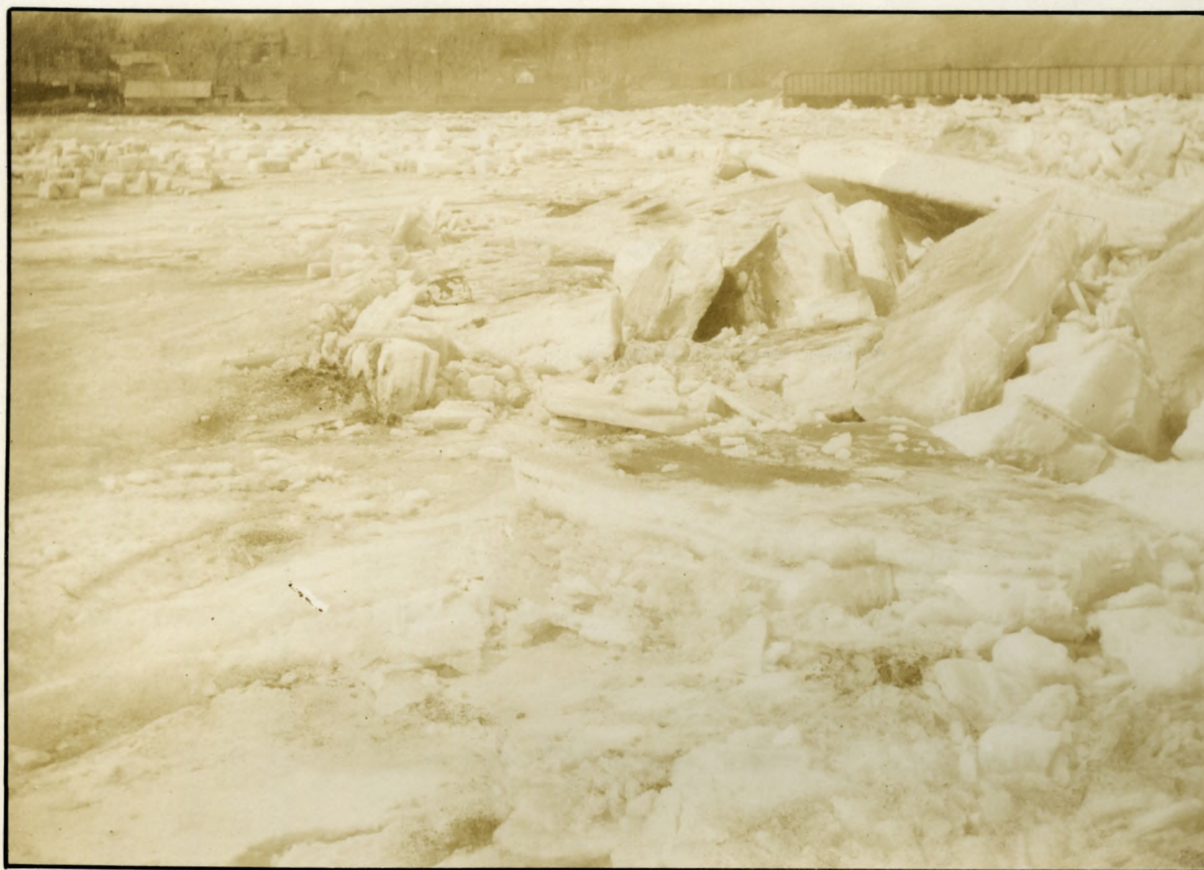
Front End of Jam, Looking West.

Taken March 22nd, 1920

It was particularly noticeable that the front of the shove had buckled and broken the bay ice, and that the latter was the cause of the stoppage of the movement.

Photographs Nos. 10 and 11 on page 23, showing the extreme south end of the jam, illustrate the manner in which the river ice attempted to make its way through the bay ice. The upstream side of the railway bridge is shown in photographs Nos. 12 and 13 on page 25, while the downstream side is shown in photographs Nos. 14 and 15 on page 26. In the background of photograph No. 14 the line of the east side of the front of the jam can be distinctly seen with the extreme front at the right-hand side of the picture. In photograph No. 15 it will be noticed that the east side of the jam was piled up against and even attempted to pass over the dyke leading to Victoria Park.

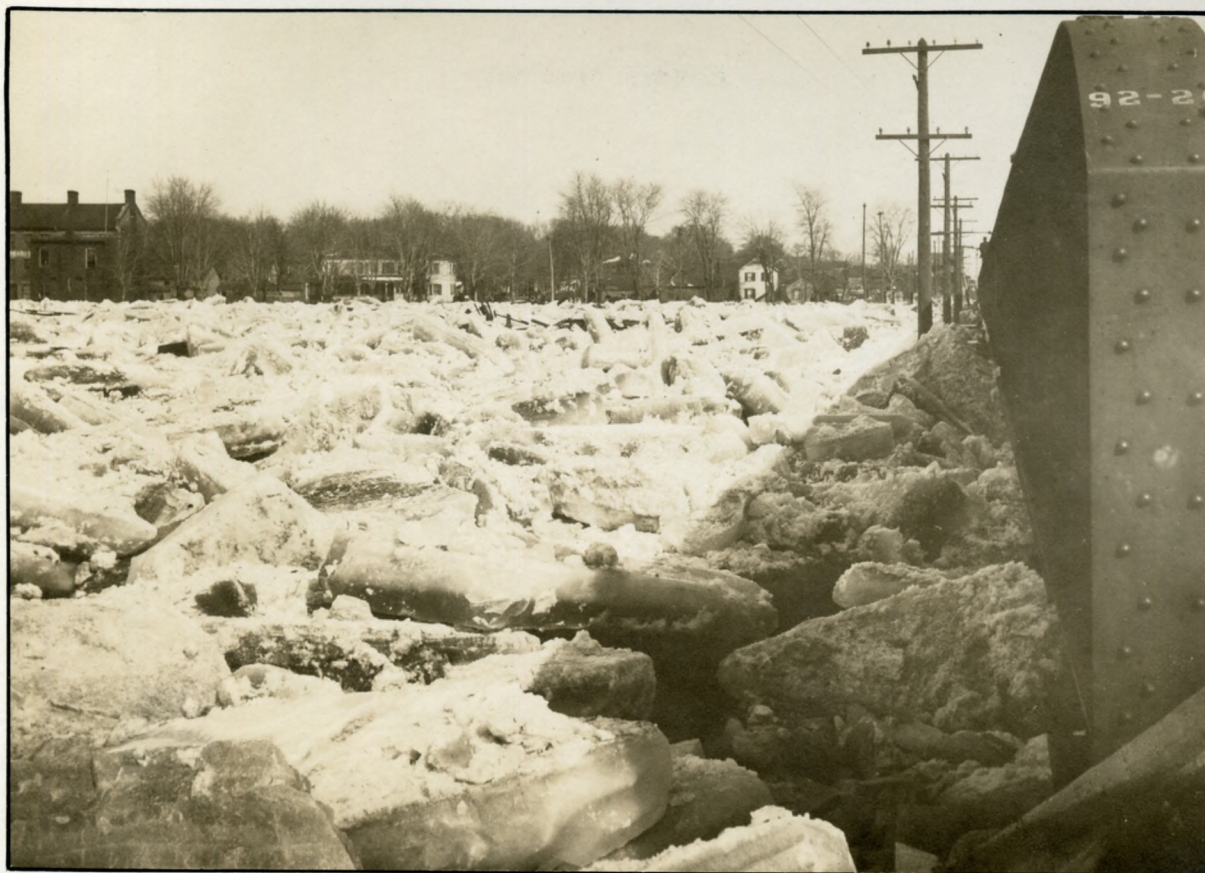
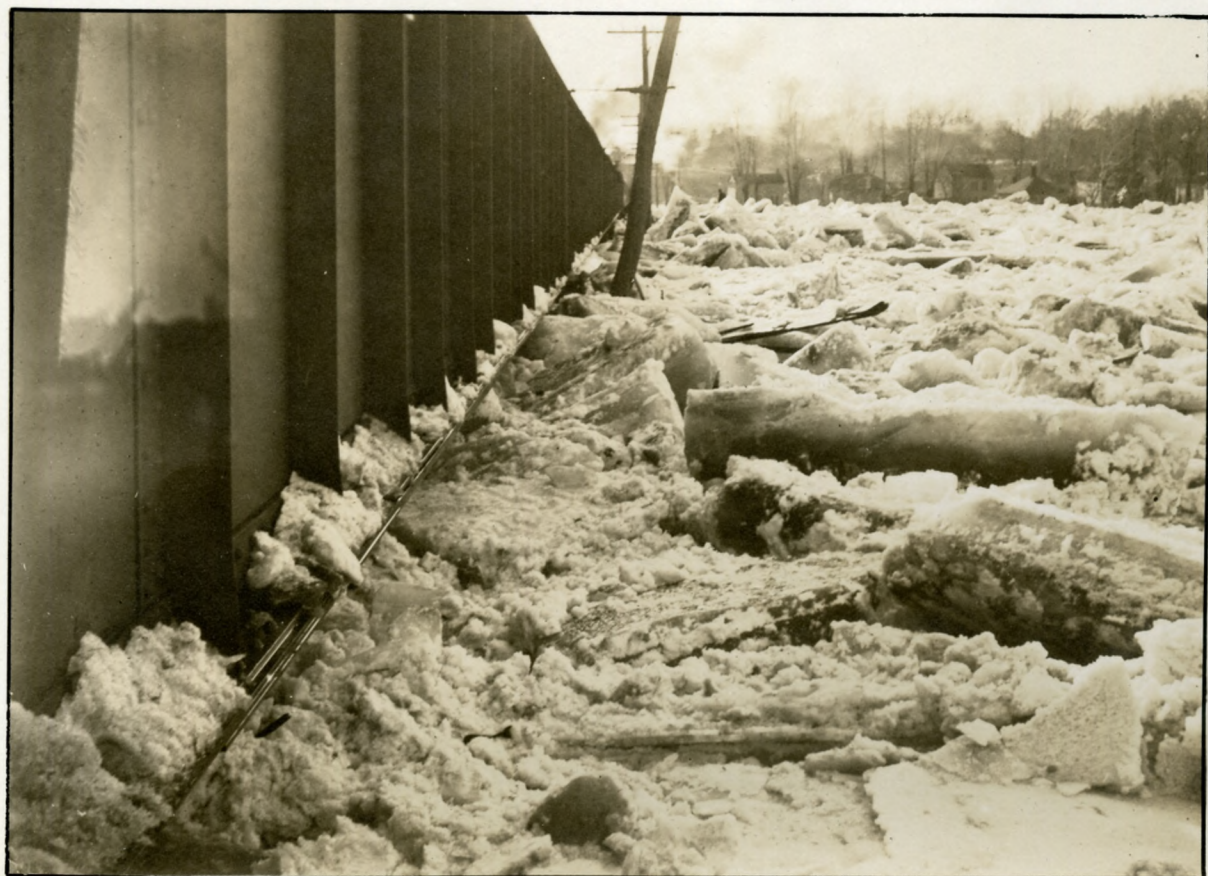
Looking West from East End.

Taken March 21, 1920.

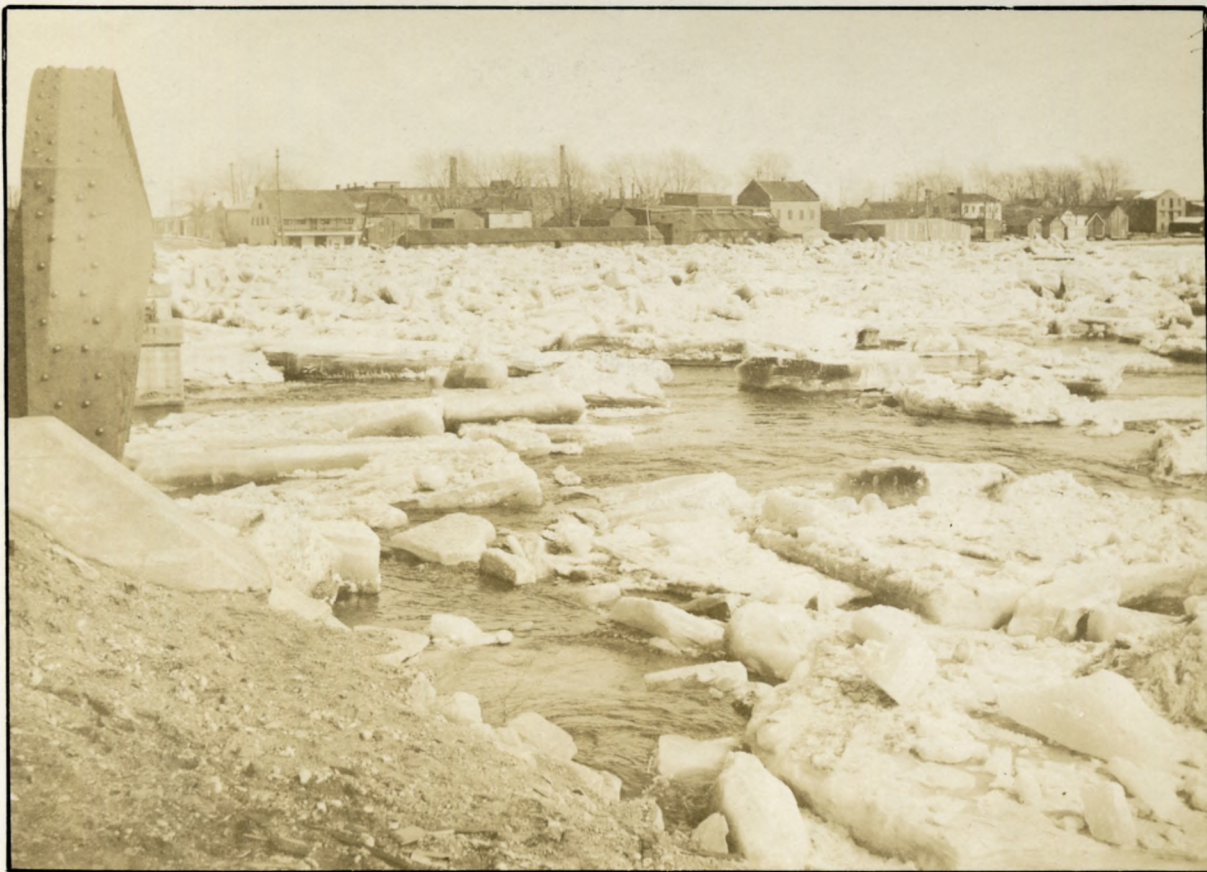
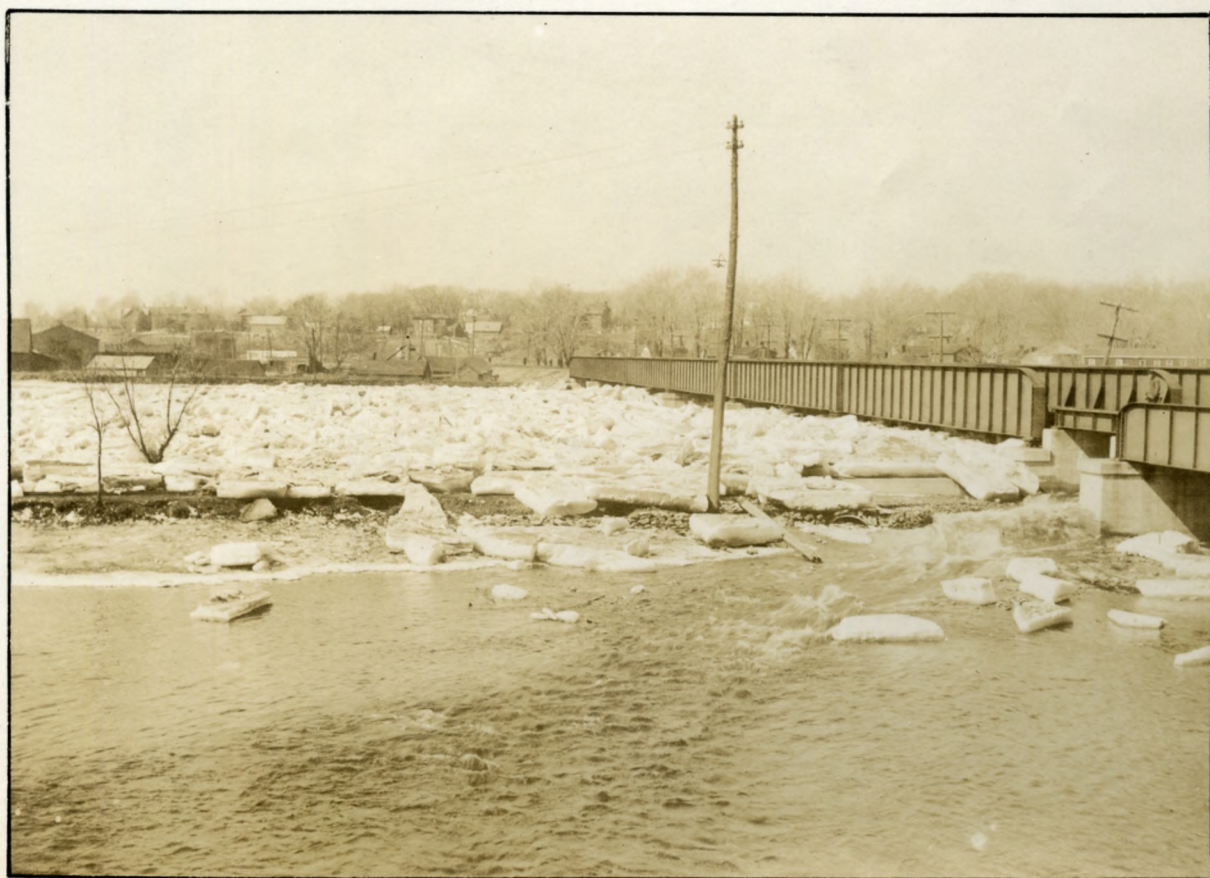
Photograph No. 14.

Downstream Side of Railway Bridge,
Looking North-West from Roblin's Boat-house.

Taken March 22, 1930.

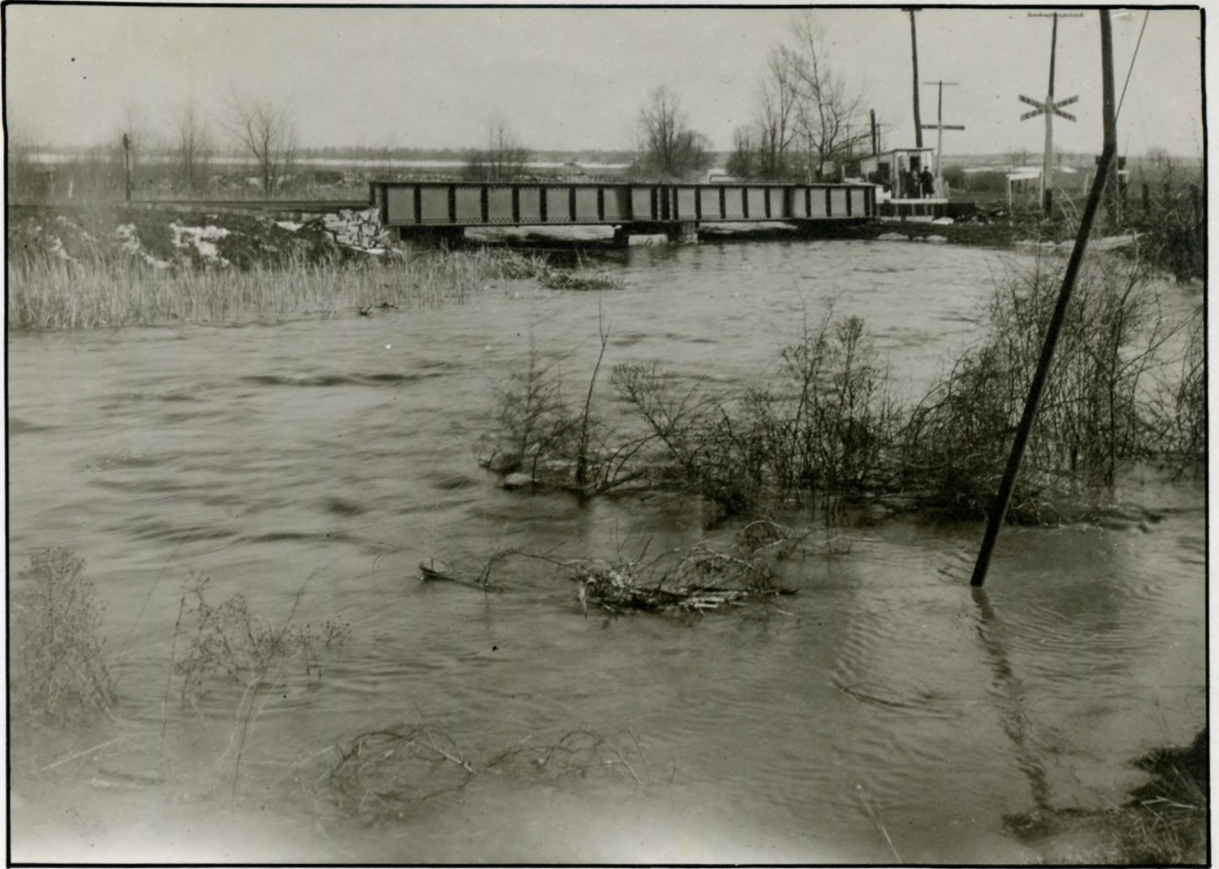
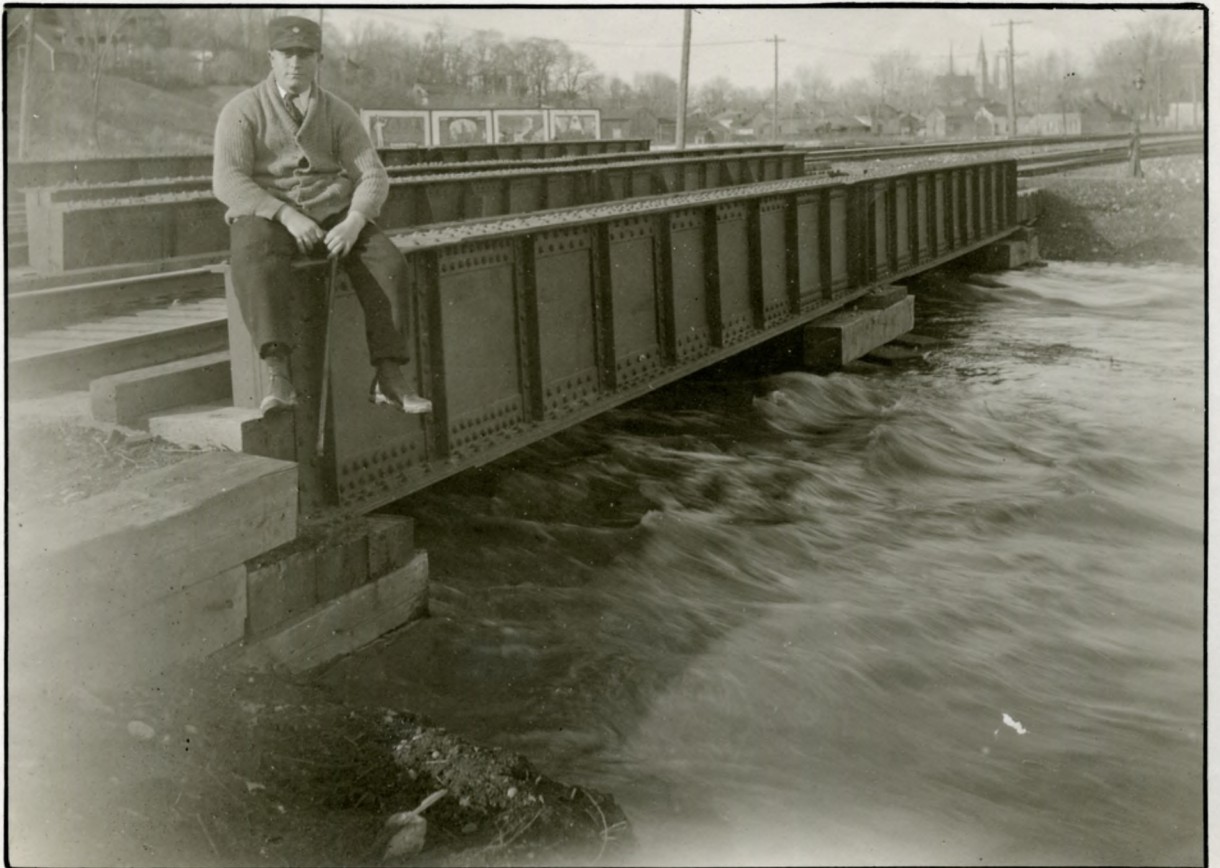
Looking East from West End.

Taken March 21, 1920, 4.15 p.m.

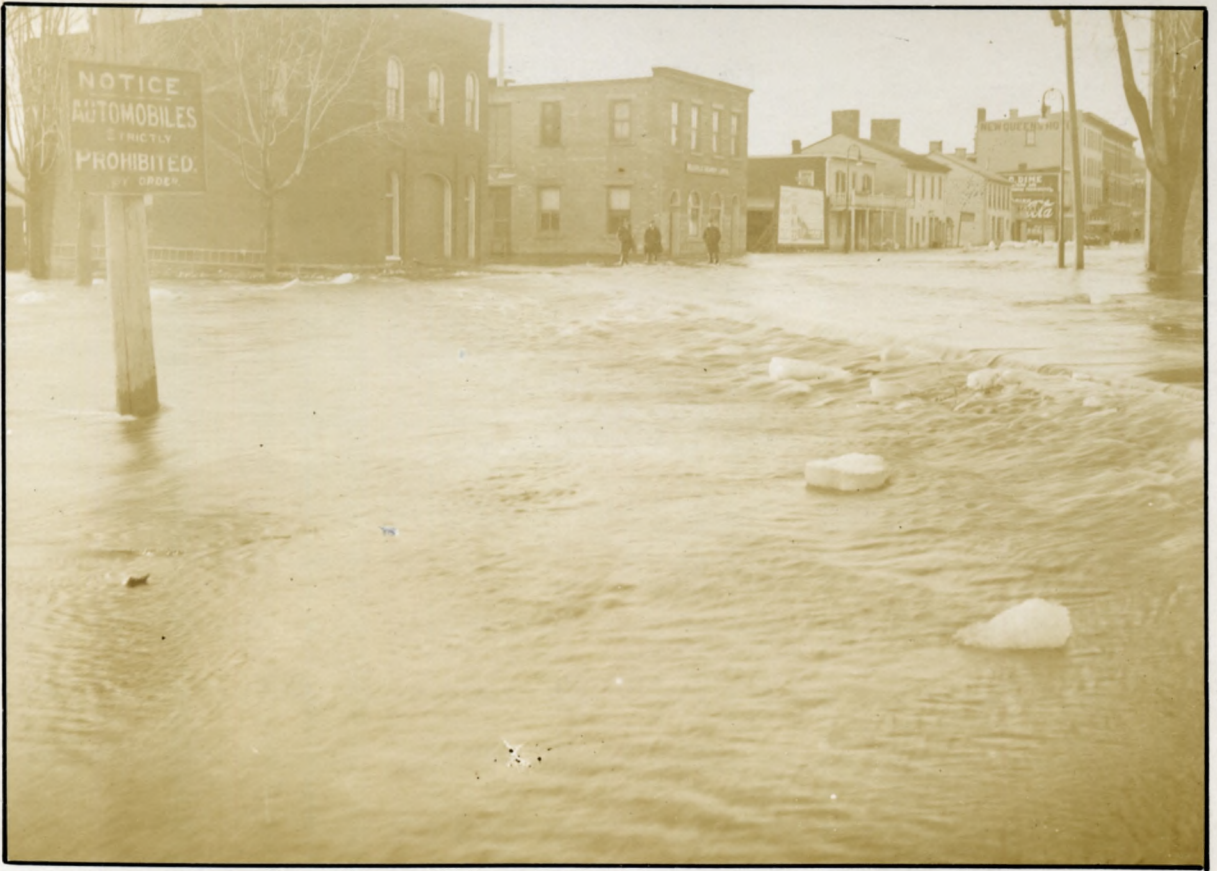
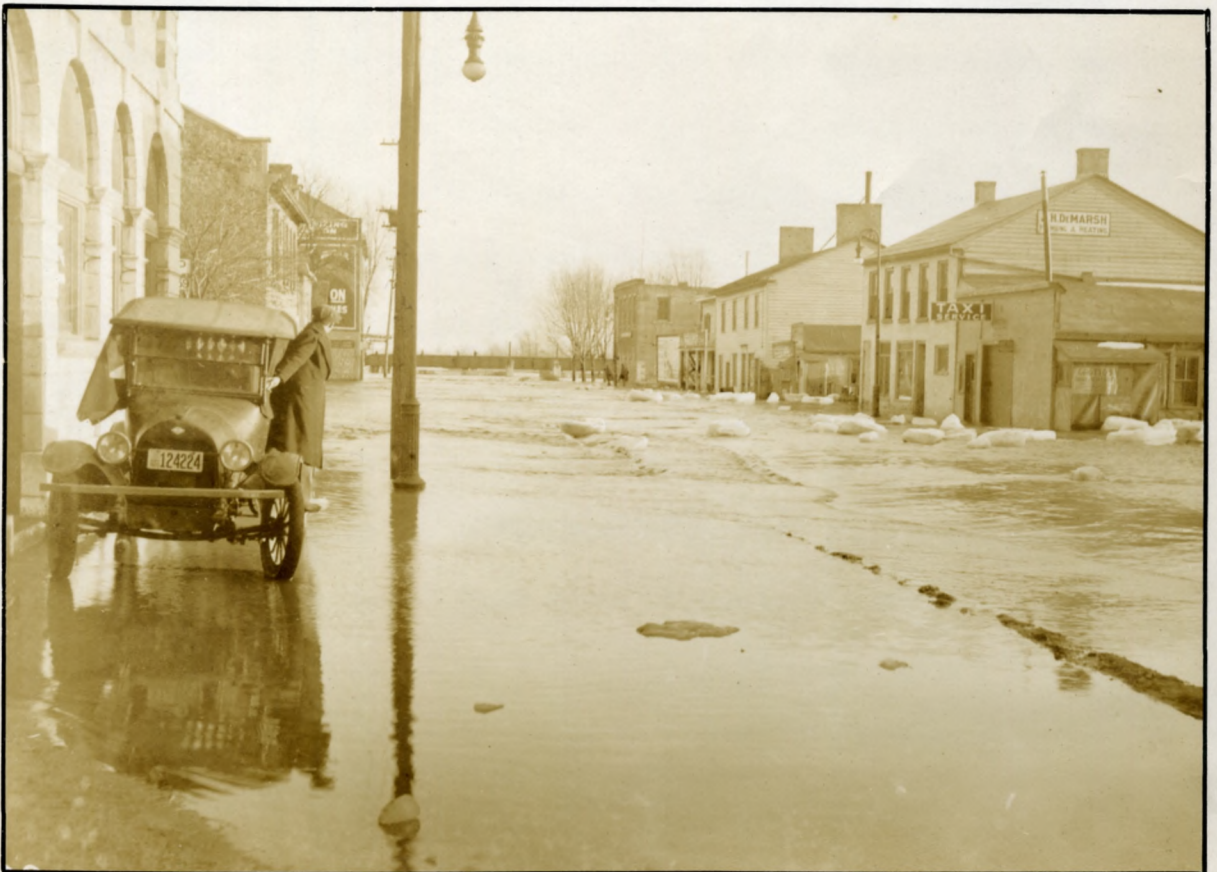
Photograph No. 20.

On the east side of the river the water overflowed the levee at a point a little south of the City Hall, and thence passed over Front Street reaching nearly to Pinnacle Street. Flowing down Front Street the water again reached the river through the subway leading to Victoria Park and down the steps leading to the boat-landing as shown by the arrows on the plan included as page 21. The water reached a maximum elevation of 253.8 at the northerly end of this area and 252.9 in the neighbourhood of Dundas Street, corresponding to a maximum depth of about 6 inches throughout. The condition at the south end of Front Street is shown in photograph No. 20 and a general view looking south along Front Street is shown in photograph No. 21, both on page 31. Both of these views were taken during the afternoon of March 21st.

Flood on Front Street,
Looking South from below City Hall.

Taken March 21, 1920.

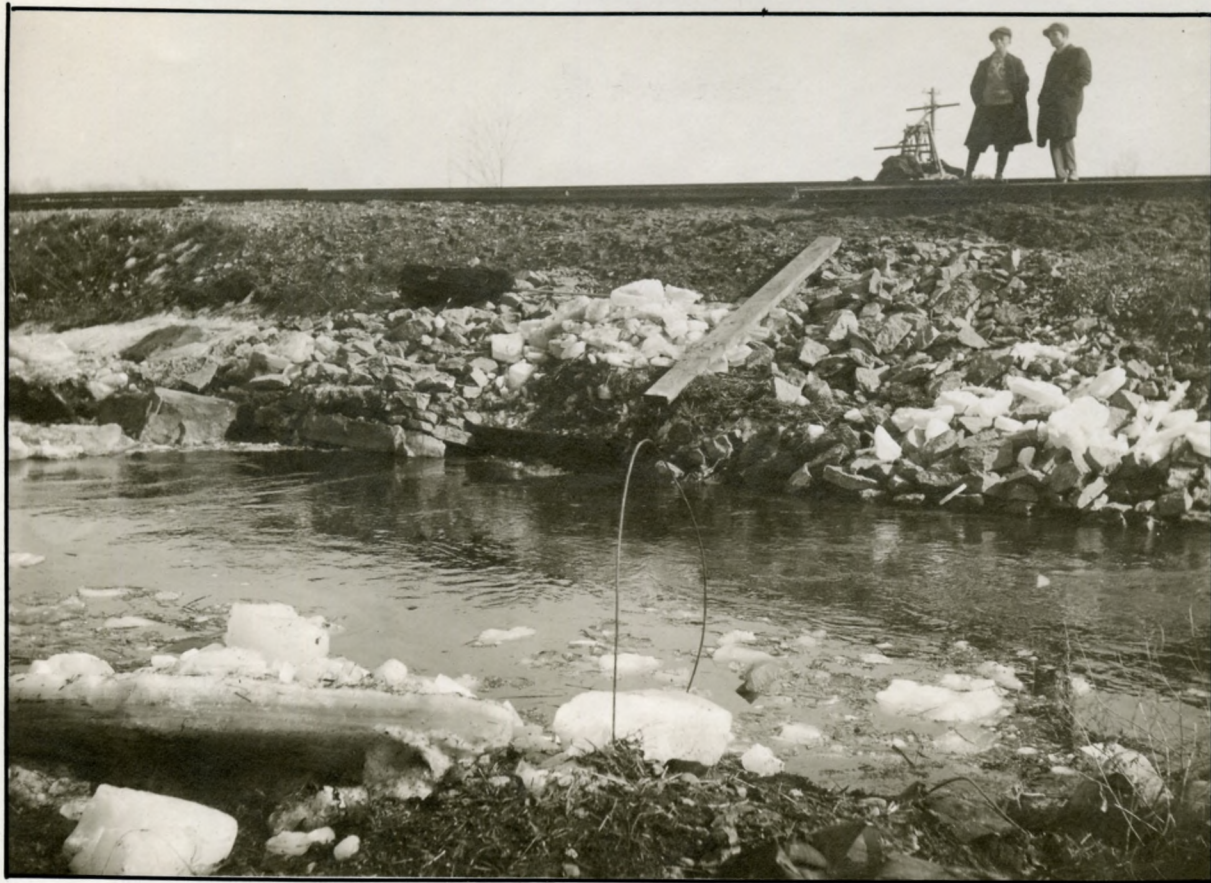
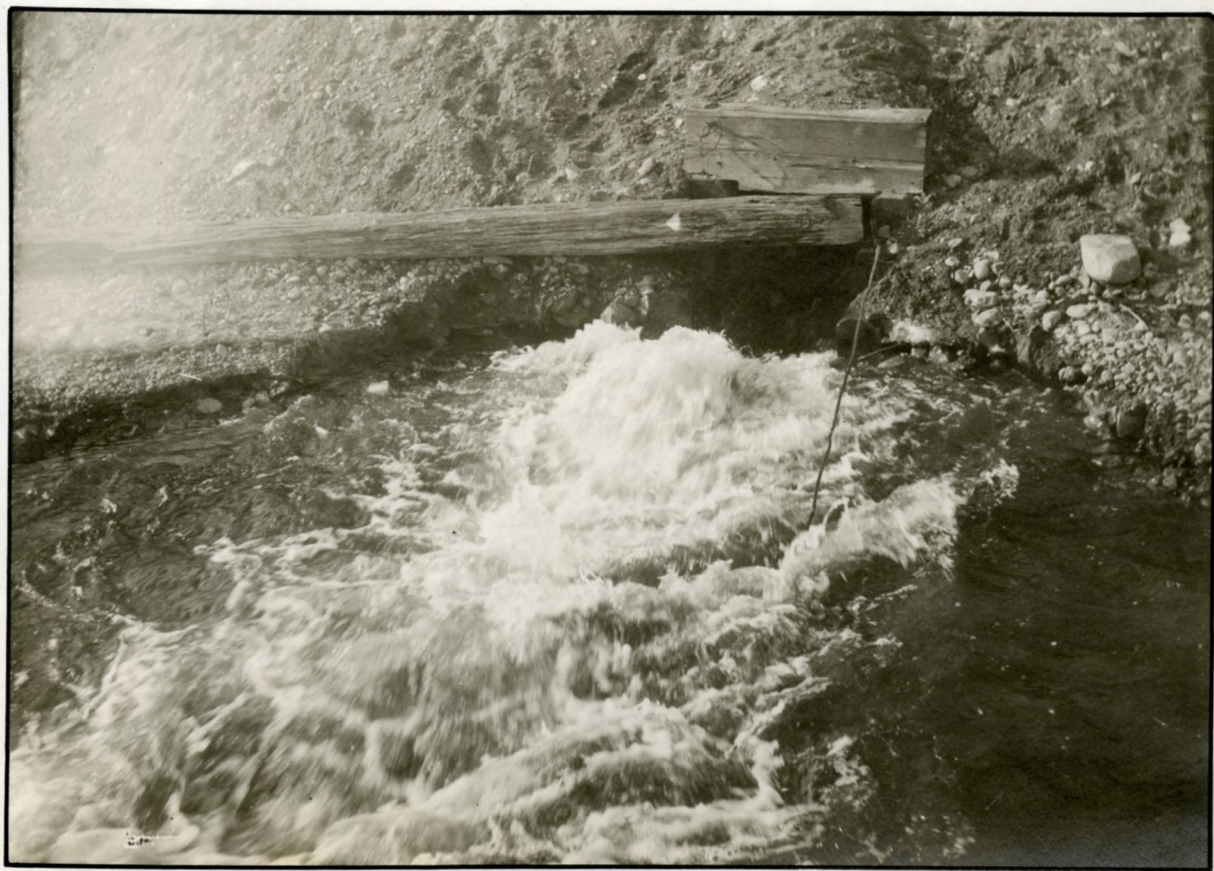
View of South End, Looking North.

Taken March 23, 1920.

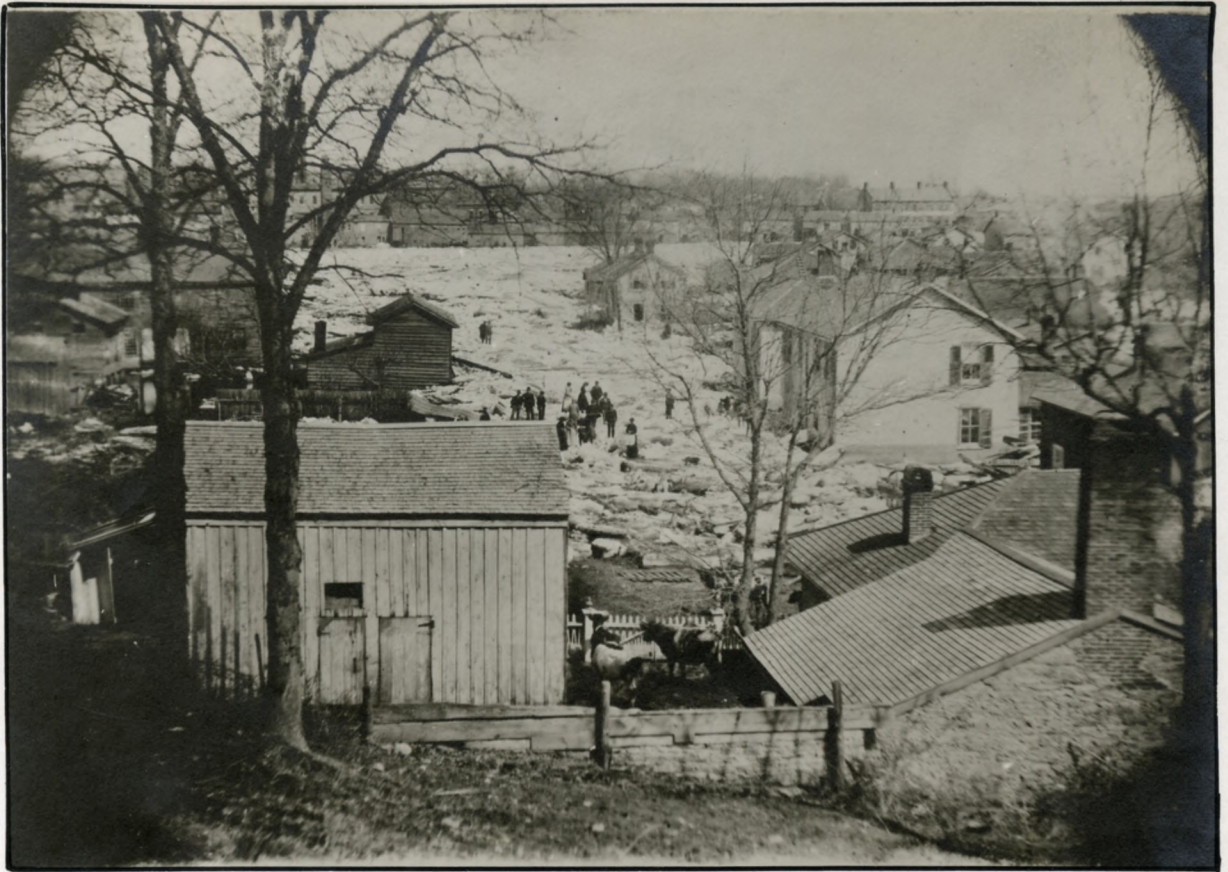
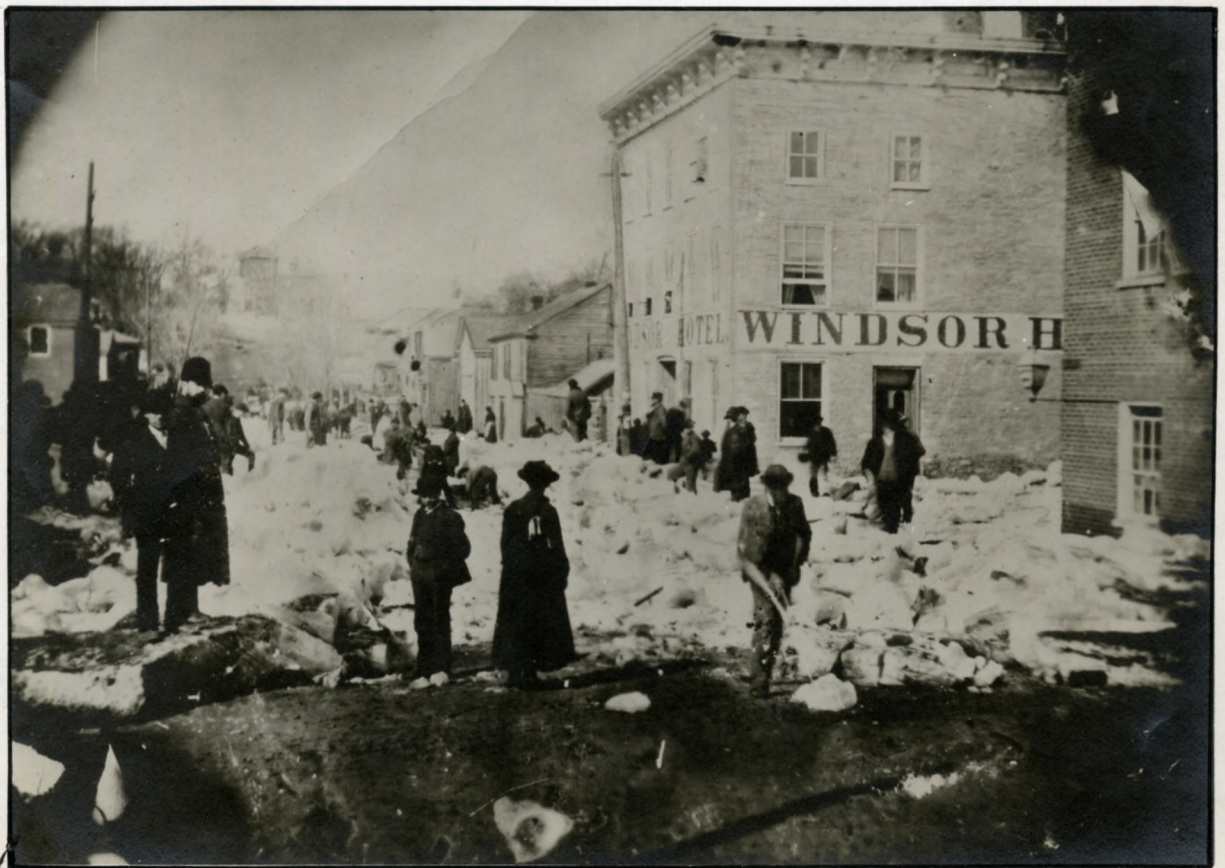
View showing Flood Conditions on Brock Street,

View showing Flood Conditions on Bridge Street, West.

Probably taken March, 1886.
